# METAL HALIDE HIGH-INTENSITY DISCHARGE (HID) LIGHTING

**FM Property Loss Prevention Data Sheets**

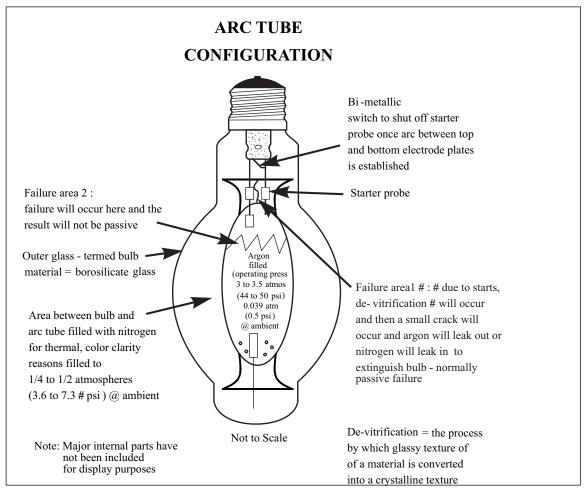
Fig. 2. Arc tube configuration

Failure of a HID lamp can occur in several ways (Fig. 2). Scratches on the outer envelope, direct contact with water, or excessive pressure can cause these lamps to break. HID lamps and their arc tubes operate at extremely high temperatures and may shatter as a result of missapplication, incorrect burning position, system failure, or other factors. De-vitrification of the arc tube glass occurs when the quartz reacts with the halogen gas. A small crack will occur normally in the vicinity of the electrode, and either the argon will leak out of the arc tube or the nitrogen gas will leak into the arc tube. Normally the lamp will fail to reignite. The probability that the arc tube will implode towards end of life increases significantly. If the lamps are cycled on and off periodically, they are much more likely to fail to restart rather than fail violently at end of life.

If an arc tube ruptures under normal operating conditions, the arc tube fragments can penetrate the outer bulb if a shroud is not effective or present. Extremely hot glass and lamp parts can be released into the surroundings if fragments are not contained by the shroud or an external shield, causing a risk of fire if combustible materials are present.

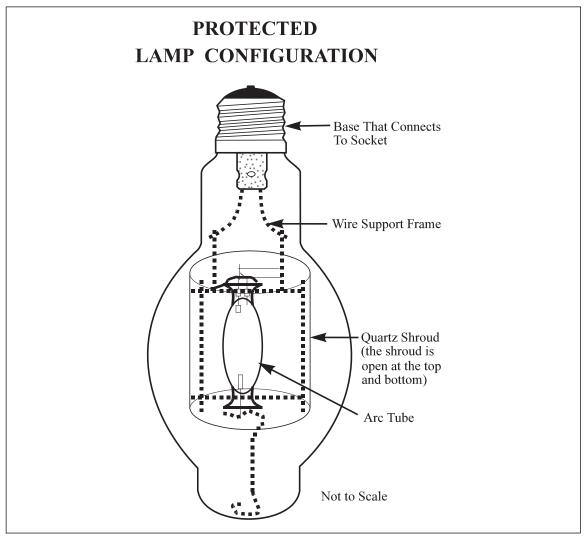
Fig. 3. Protected lamp configuration

A typical shrouded HID lamp is shown in Figure 3. The shroud may be constructed of quartz, alumina silicate, or steel mesh. Lamps with this design that have passed a consensus NEMA industry-developed test are rated as "O" bulbs for use in open fixtures. Based on this testing, these lamps are expected to always contain arc tube fragments in the case of a violent arc tube rupture. (Older lamps of this type may have an "MP" rating rather than the newer "O" rating.) This test was developed based on shrouded lamps and is only appropriate for lamps with that type of construction.
