CORROSION IN AUTOMATIC SPRINKLER SYSTEMS

1.0 SCOPE

This data sheet provides recommendations that are intended to address the prevention and control of corrosion in automatic sprinkler system piping.

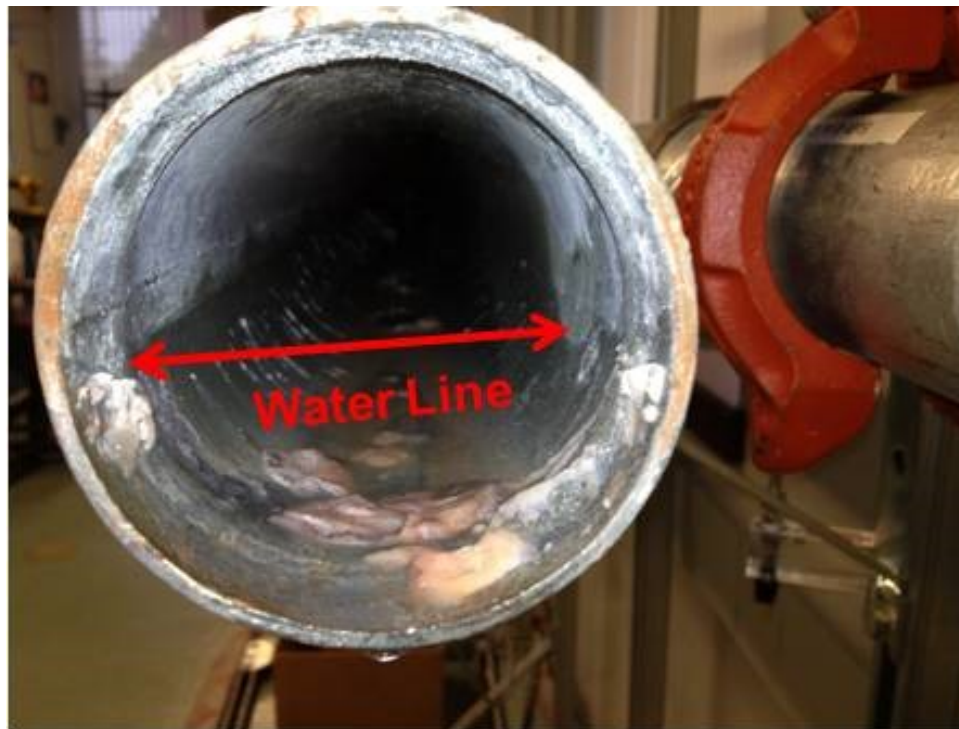
Figures 4a and 4b are photographs of galvanized steel pipe half-filled with tap water in house air (4a) and in compressed nitrogen (4b) after nearly six weeks' exposure. Whitish zinc corrosion products covered the bottom half of the house air-filled pipe in Figure 4a, but only limited zinc corrosion products covered the bottom half of the compressed nitrogen-filled pipe (Figure 4b). This result indicates that compressed nitrogen can reduce corrosion of galvanized steel pipe containing trapped water.

Fig. 4b. Galvanized steel pipe half-filled with compressed nitrogen after nearly six weeks' exposure

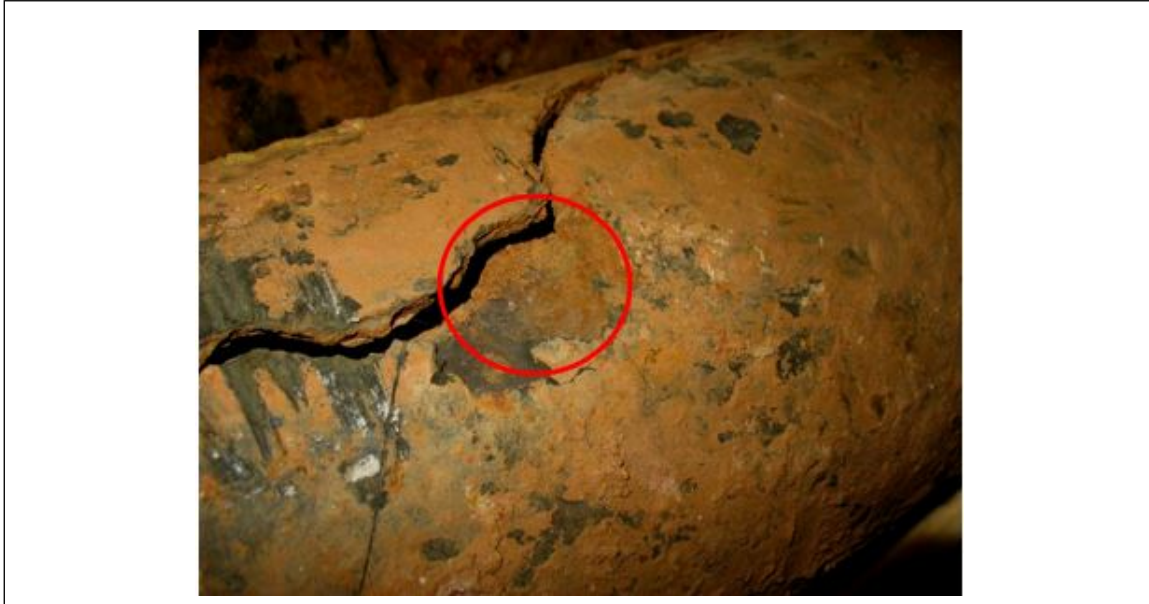
Figure 7 shows a ruptured underground water main (identified as gray cast iron, 8 in. [20.3 cm] diameter) with cement lining on its inside diameter. The circled area in Figure 7 shows graphitic corrosion on the outside surface of the main due to its exposure to mildly aggressive groundwater and soils. Generally, high moisture content in the surrounding soil is required for graphitic corrosion to occur.

Fig. 7. Ruptured underground water main (identified as gray cast iron, 8 in. [20.3 cm] diameter) with cement lining on its inside diameter

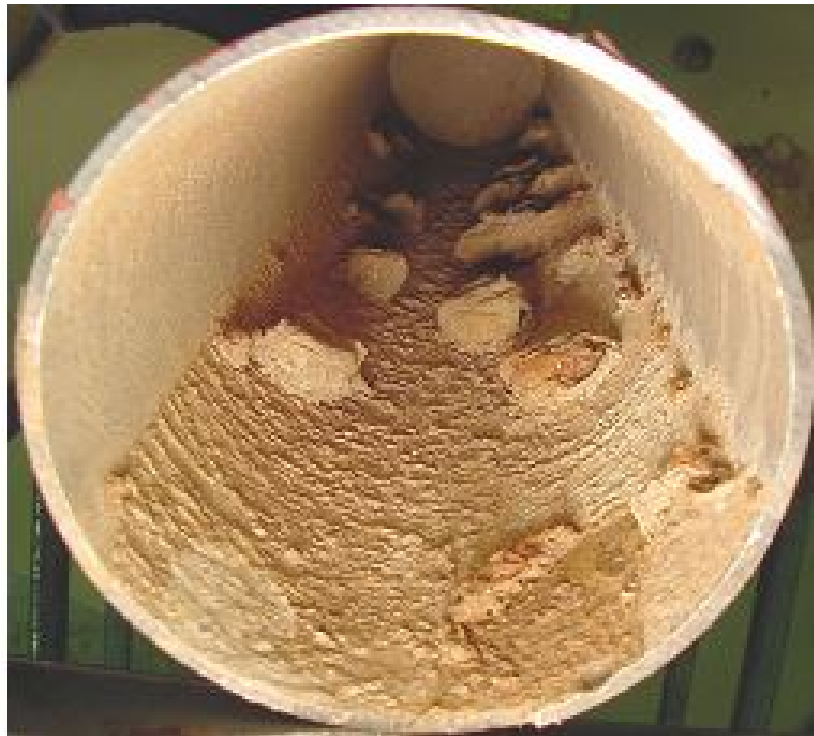
Figure 9a shows tubercles and and Figure 9b shows pinhole leakage (circled) in galvanized steel sprinkler pipe from dry-pipe systems.

Fig. 9a. Tubercles that formed inside a galvanized steel sprinkler pipe (4 in. [10 cm] diameter)

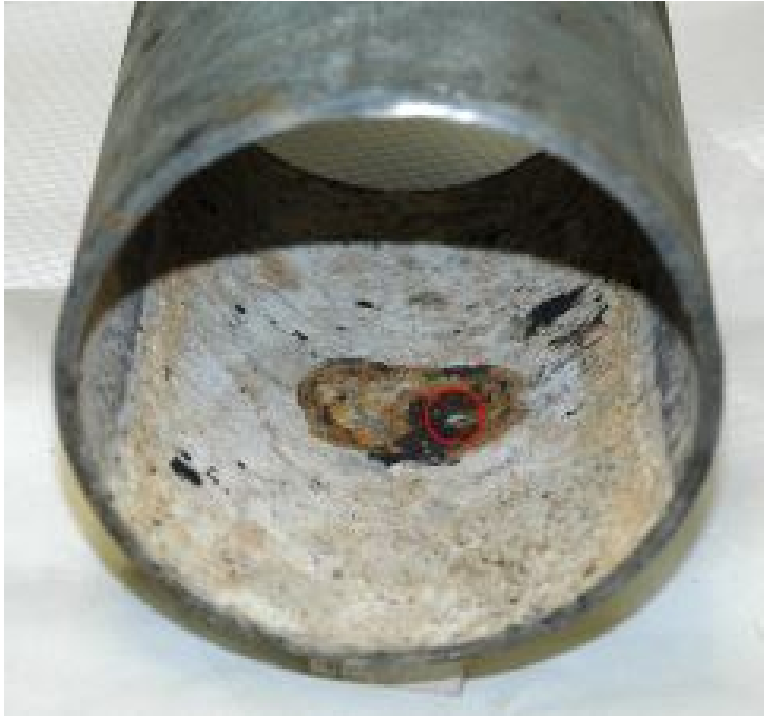
Fig. 9b. Corrosion at the base of a tubercle, which ultimately led to through-wall leakage

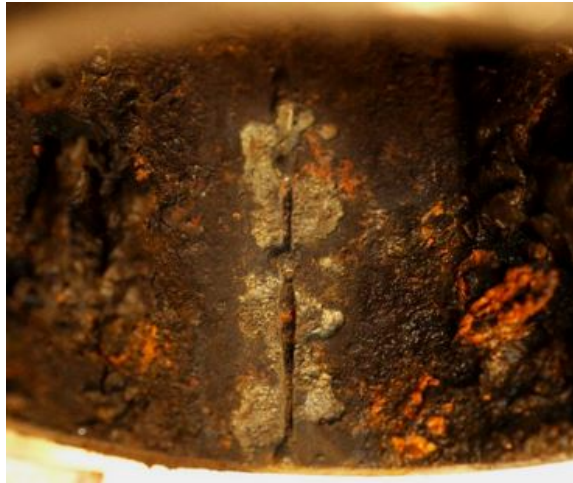
Figure 11b shows the waterside of the pipe in the region corresponding to the leakage site, after removal of corrosion products. Preferential attack surrounding the weld seam is severe.

Fig. 11b. Leakage on an NPS 2½ steel sprinkler pipe in a wet pipe system after removal of corrosion products; preferential attack surrounding the weld seam is severe

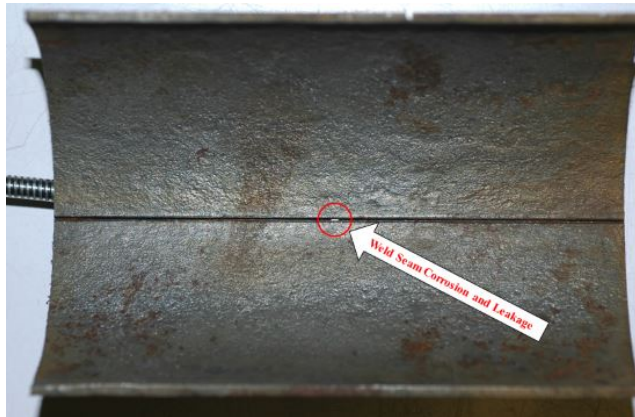
Figure 12 shows an example of preferential grooving corrosion on a pipe weld seam with a .04 in. (1 mm) pinhole leak in a wet-pipe system, after removing corrosion products inside an NPS 3 pipe.

Fig. 12. Preferential grooving corrosion on a pipe weld seam with a .04 in. (1 mm) pinhole leak in a wet pipe system, after removing corrosion products inside an NPS 3 pipe

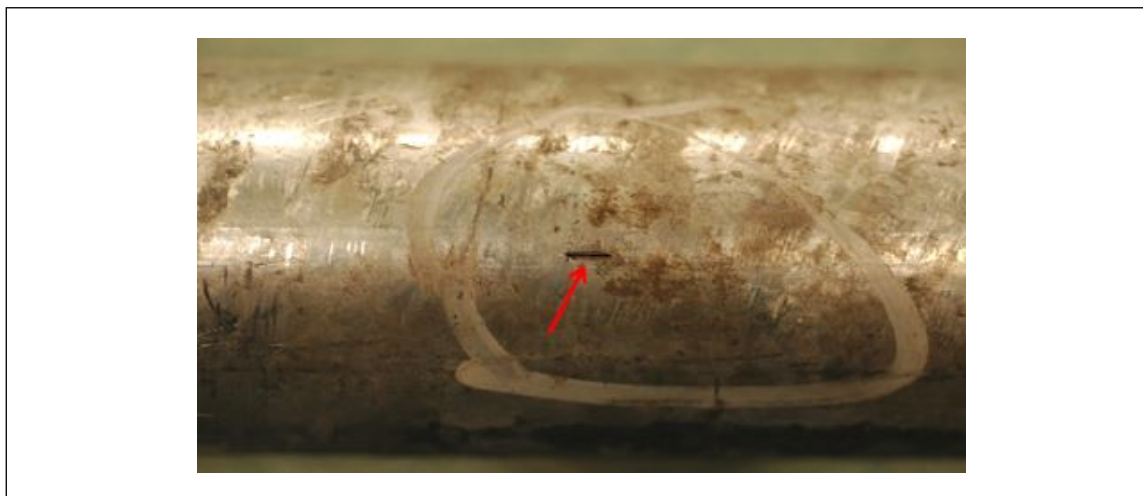
Figure 14 shows another preferential grooving corrosion attack surrounding the weld seam area for a preaction system, near the pipe's 6 o'clock (bottom) installed position.

Fig. 14. Preferential grooving corrosion attack surrounding the weld seam area for a preaction system, near the pipe's 6 o'clock (bottom) installed position

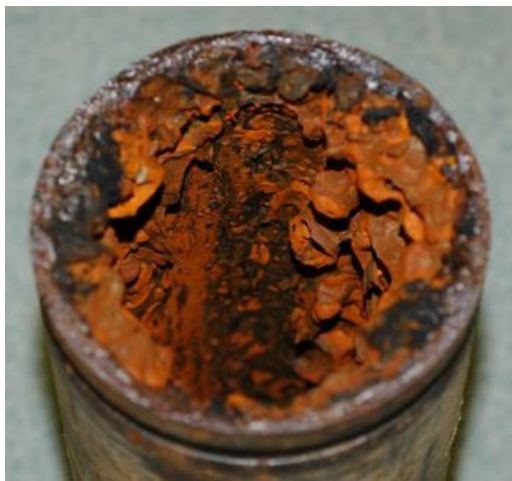
Figure 15 is an example of a 4 in. (10 cm) diameter corroded/leaking steel pipe with many tubercles formed inside the pipe. MIC caused by SRB was identified to be a likely contributing factor to the corrosion based on testing results of SRB immunoassay, lead acetate sulfide tests, water chemistry analyses, and corrosion/metallurgical evidence.

Fig. 15. Corroded steel pipe with many tubercles inside
