PLASTIC AND PLASTIC-LINED TANKS

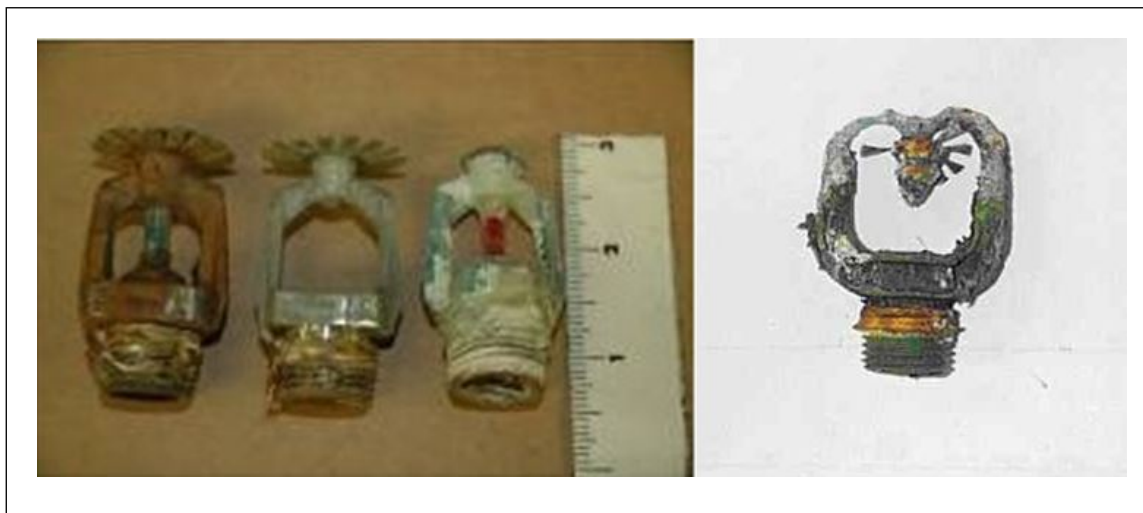
Fig. 1. Corrosion-damaged fire protection components

2.5.2 Conduct quarterly visual inspections of the fire protection system (sprinklers, valves, pipe work, and detectors) for signs of corrosion. Replace components as needed. (Figure 1 shows examples of corrosion-damaged fire protection components.)
